**HAZARDOUS MATERIALS ASSESSMENT**  
**Province House Annex**  
**180 Richmond Street, Charlottetown, PE**

April 6, 2023

ALL-TECH Project No.: PE22400

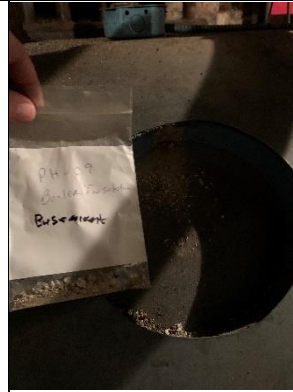
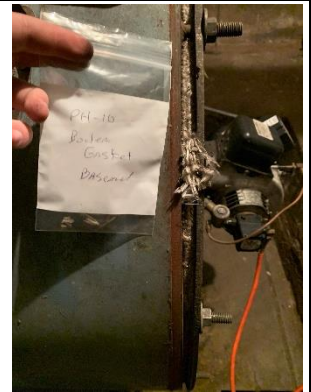
Accessible insulation within boiler jacket and boiler gasket sampled and found to be non-asbestos containing.

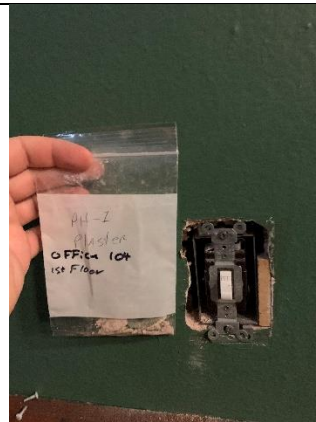
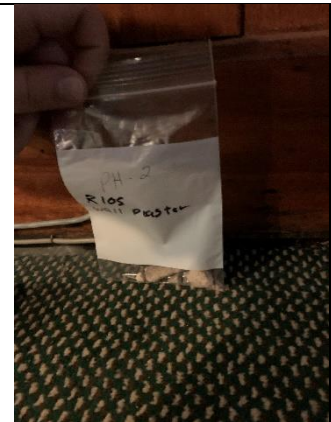
Plaster walls and ceiling were noted and sampled in various random locations throughout the building. Representative sampling was completed on each floor of the building. A total of eleven (11) plaster samples were collected with both the white scratch coat and underlying base coats analyzed. None of the samples were found to contain asbestos.

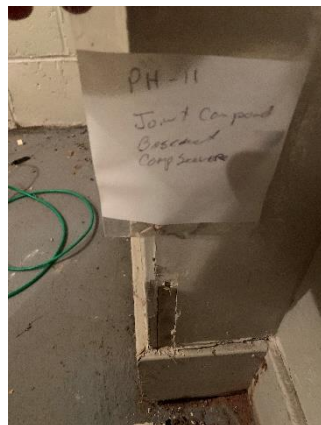
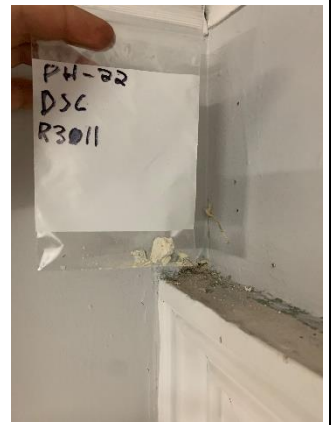
Drywall joint compound walls and ceilings were noted and sampled in various random locations throughout the building. A total of eight (8) joint compound samples were collected during the assessment. Two samples sampled in the basement level were found to contain **1.5% -2.1% Chrysotile** asbestos. One sample on the third floor was found to contain **1.4% Chrysotile** asbestos.

All other samples collected were reported as non asbestos containing.

Drywall joint compounds confirmed as ACM in one location on 3rd floor as well as the basement level. Therefore, other drywall joint compounds to be presumed asbestos containing unless additional sampling proves otherwise.

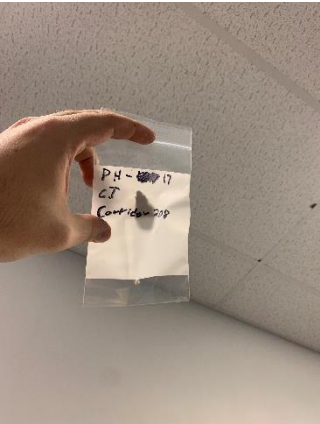
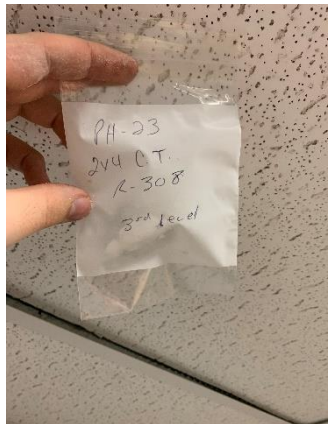
<p>In-lay acoustic fissure ceiling tiles were observed and sampled in some locations throughout the building.</p> <p>The ceiling tiles were observed as like materials throughout.</p> <p>Three fissure design ceiling tiles were collected during the assessment. None of the samples were found to contain asbestos.</p>

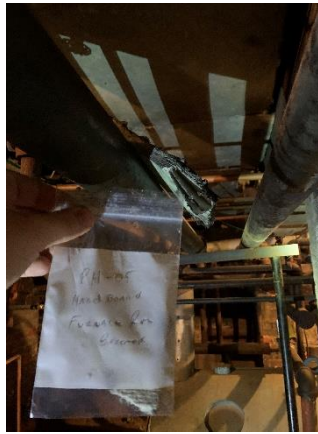
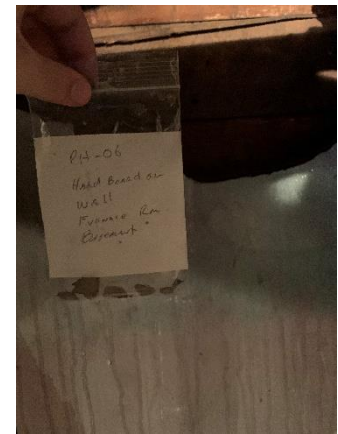
Transite hardboard samples were collected from the walls and ceiling in the basement level areas. The material was found to contain **25% - 30% Chrysotile** asbestos.

Room No.	Description	Sample No.	Material description	Asbestos Type & Content (%)	Estimated Volume or Area	Friable (F) Non-friable (NF)	Access	Condition	Action Code (refer to legend)	Photo
NA	Basement furnace room	PH-05 PH-06	Transite hardboard ceiling Transite hardboard wall	Chrysotile 30% Chrysotile 25%	83 m2	NF	B	Good	5

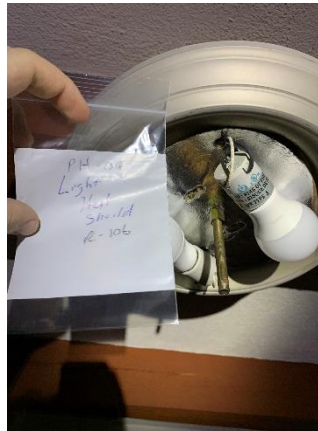
A light heat shield was sampled in the kitchen area on the first floor. The material was analyzed and reported as a non-asbestos material.

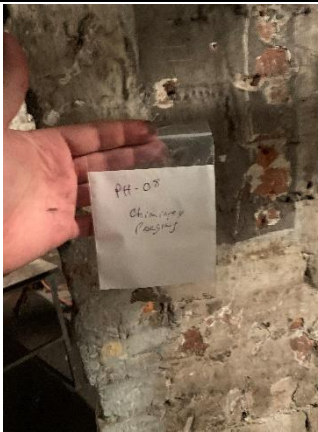
A parging cement sample was collected on the chimney in the basement storage area. The material was analyzed and reported as a non-asbestos material.

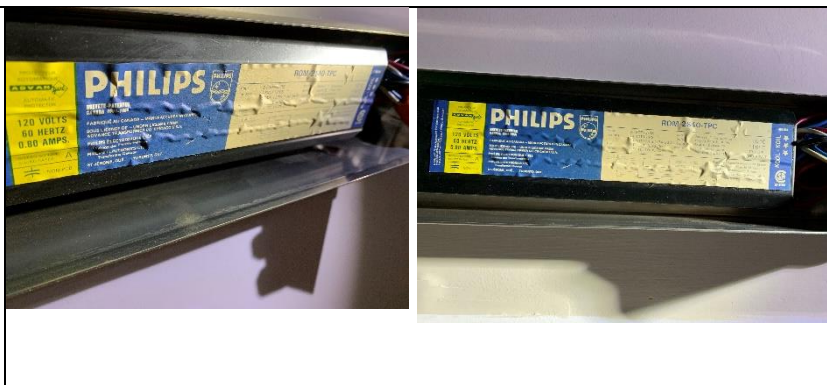
Photo 1 – Philips RQM Lamp Ballasts.  
Ballast marked as non-PCB's.

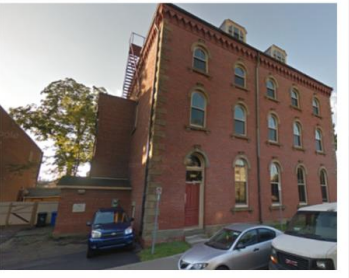
Room No.	Location	Sample No.	Material	Comments	Photo
NA	Exterior	NA	Brick and mortars; plasters; stone
