## **CAMPBELLTON CREEK FISH KILL 2017**

### **PRELIMINARY REPORT**

**September 2017**

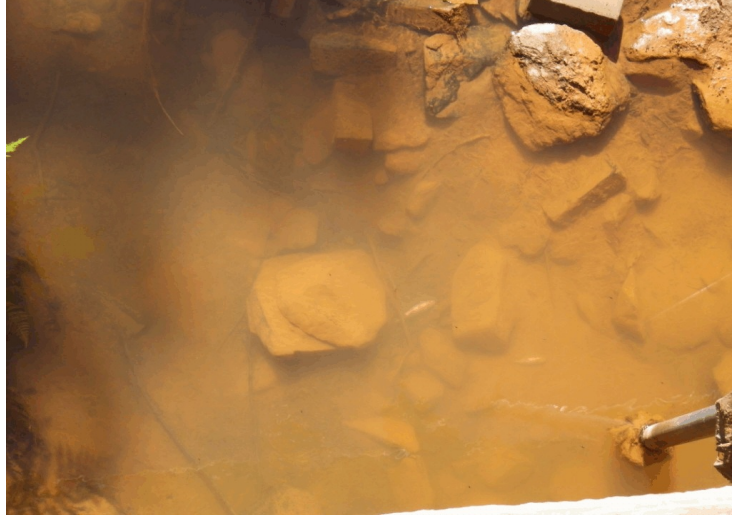
Figure 2. Two dead brook trout visible in turbid water upstream from the Coughlin Road bridge. July 23, 2017

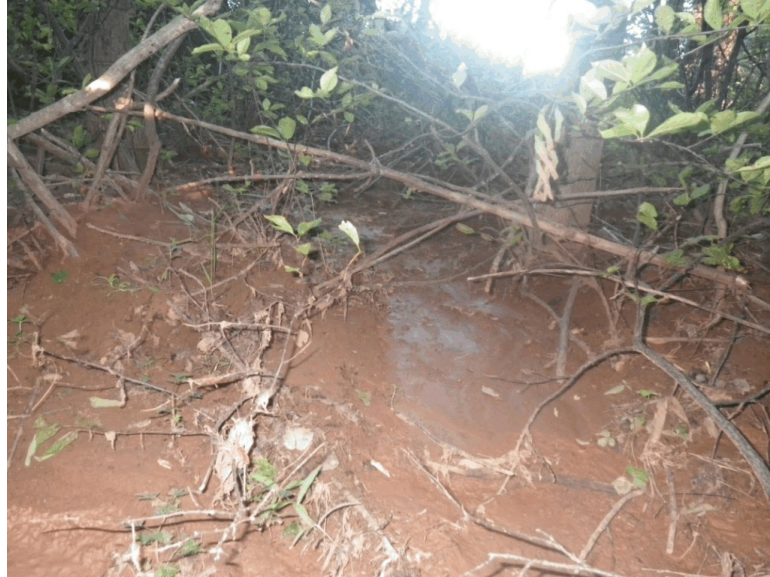
Figure 4. Sediment deposited in the flood plain of Campbellton Creek, upstream from the Coughlin Road. July 23, 2017

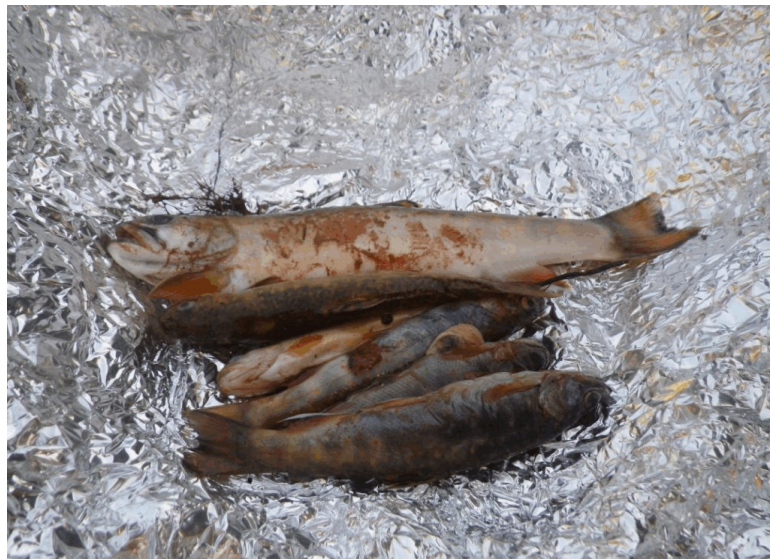
Figure 5. A sample of dead fish collected in Campbellton Creek. July 23, 2017.

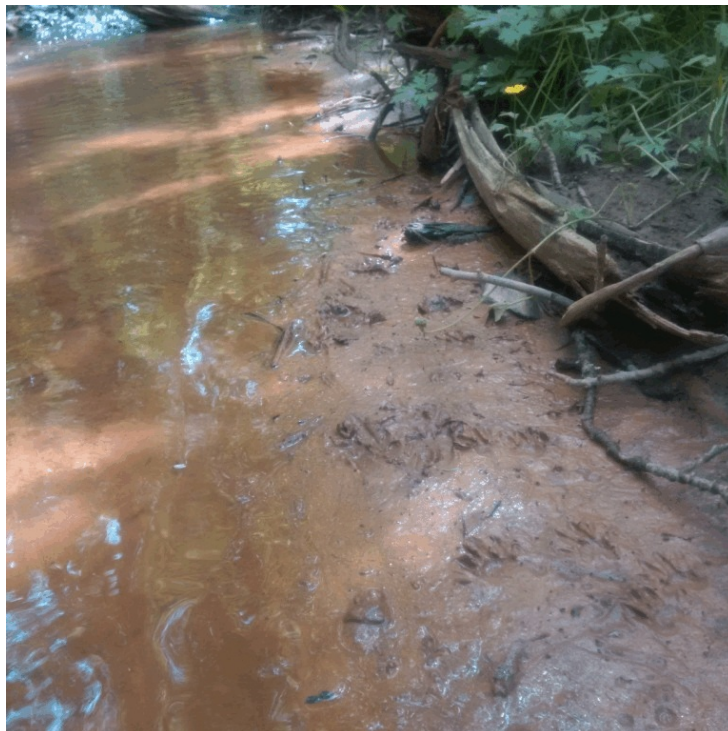
Figure 7. Raccoon tracks in the mud downstream from the Coughlin Road. July 24, 2017
