**HAZARDOUS MATERIALS ASSESSMENT**  
**Province House Annex**  
**180 Richmond Street, Charlottetown, PE**

April 6, 2023

ALL-TECH Project No.: PE22400

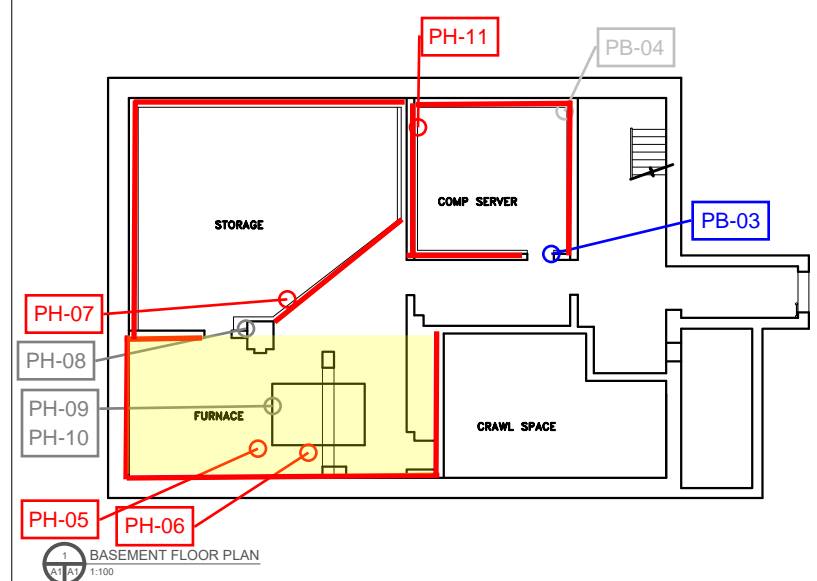
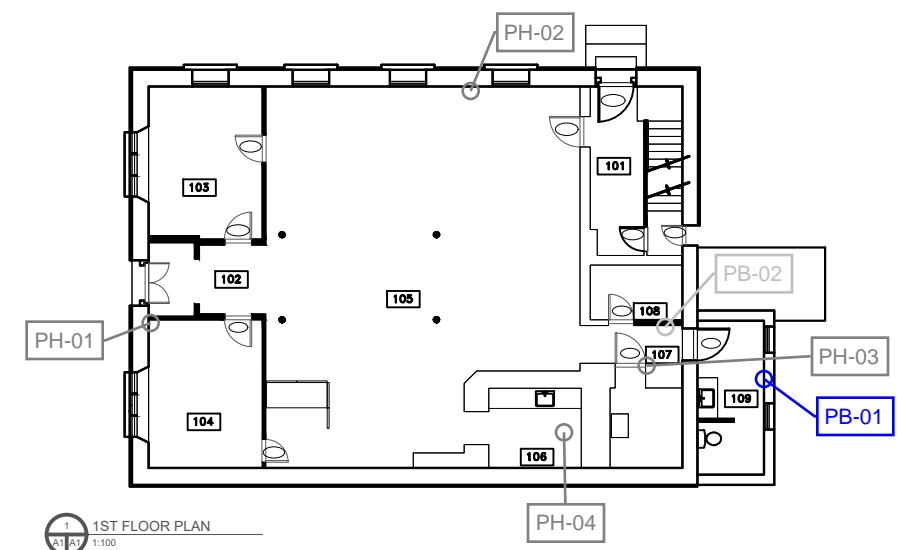
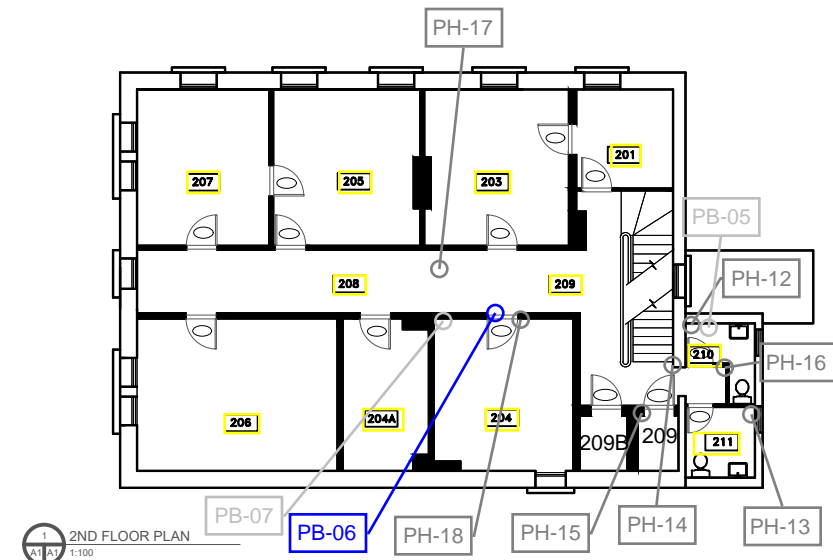
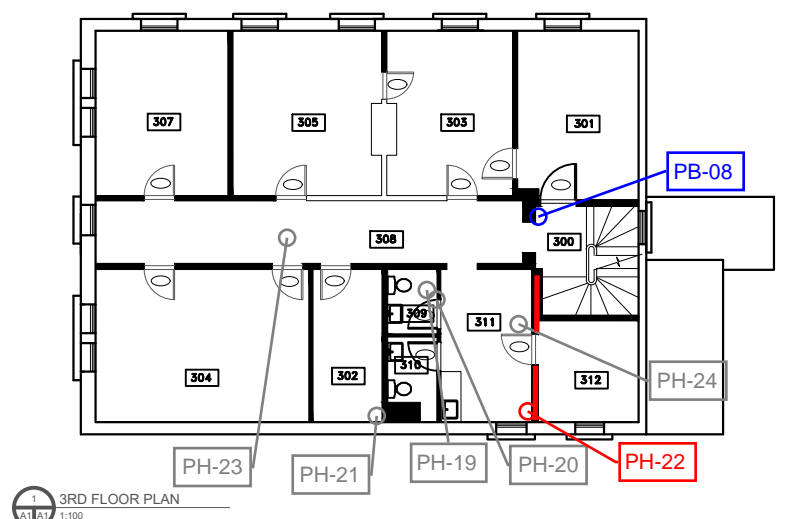
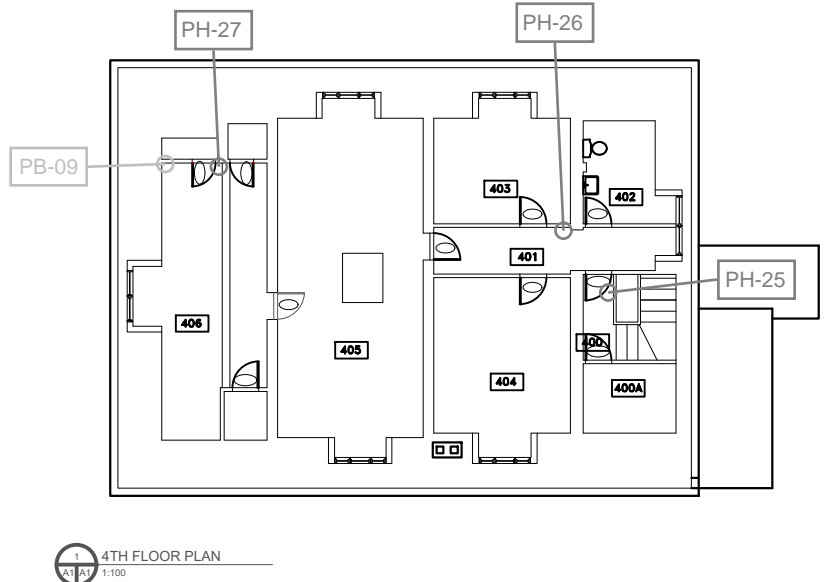
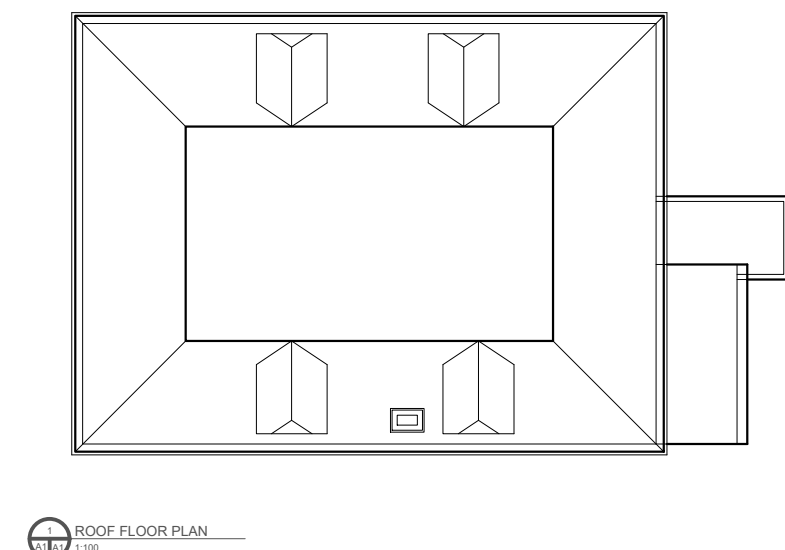
Drawing: PROVINCIAL HOUSE ANNEX ALL FLOORS  
 Design: LK  
 Date: FEB\_2023  
 Drawn: AJH  
 Date: MAR\_2023

Drywall joint compounds confirmed as ACM in one location on 3rd floor as well as the basement level. Therefore, other drywall joint compounds to be presumed asbestos containing unless additional sampling proves otherwise.
